NBSIR 74-528 (R)

DNA/NBS/Crane NAD Barrier Tests

Report for Period March 24 – 29, 1974

Defense Nuclear Agency
Washington, D. C. 20305

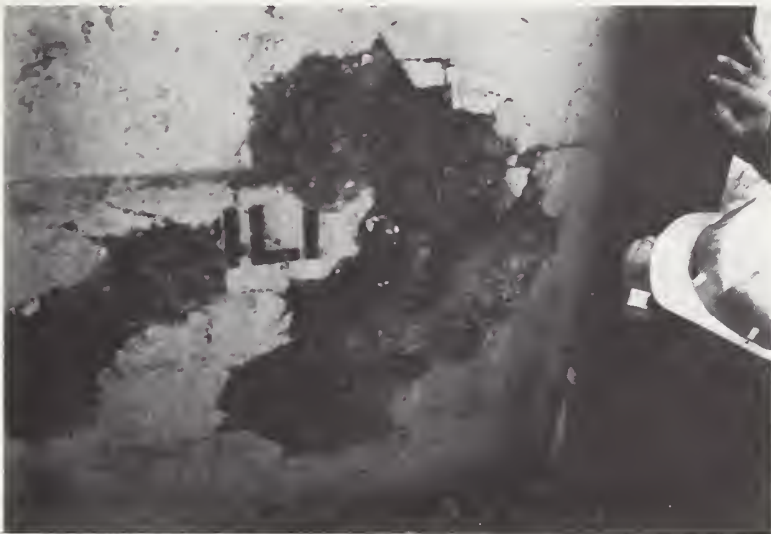
Figure 5. 4L1. Slab 4, rear view of results of 17-round burst of 20 mm APT

As in the preceding test, a target area was selected and then a 17 round burst of the 20 mm APT was fired at this target. Figures 4 and 5 show front and rear views of the resulting damage. The fibrous concrete in this slab was more difficult to clear away and 75 blows were required from a

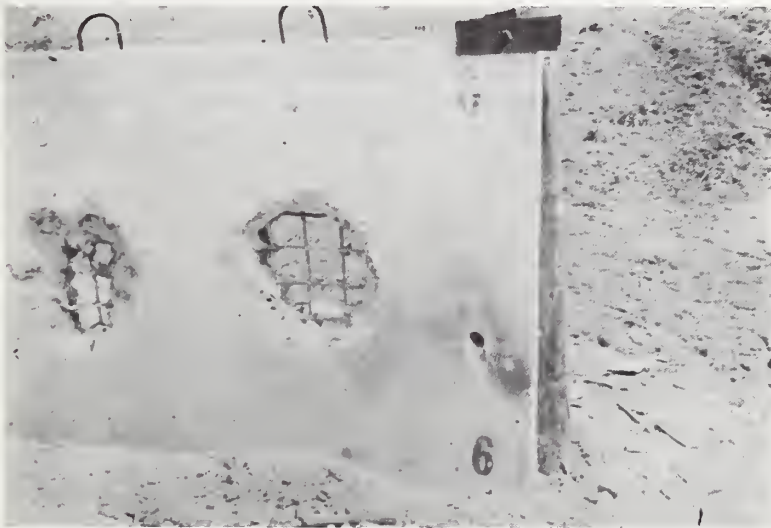
Figure 12. 6E2. Slab 6 after 44.45 minutes working time

Next, four more holes were drilled partially through the slab near the center of the annulus. These were spalled and then a direct sledgehammer attack eventually produced a small central initial breakthrough. Using a combination of tapered punches and direct sledgehammer attacks, the peripheral holes were enlarged and spalled into the central breakthrough region. It required a total of 44.45 minutes of working time to make the opening shown in figure 12. It is estimated that it would have required at least two more minutes to cut the reinforcing bars with bolt cutters.

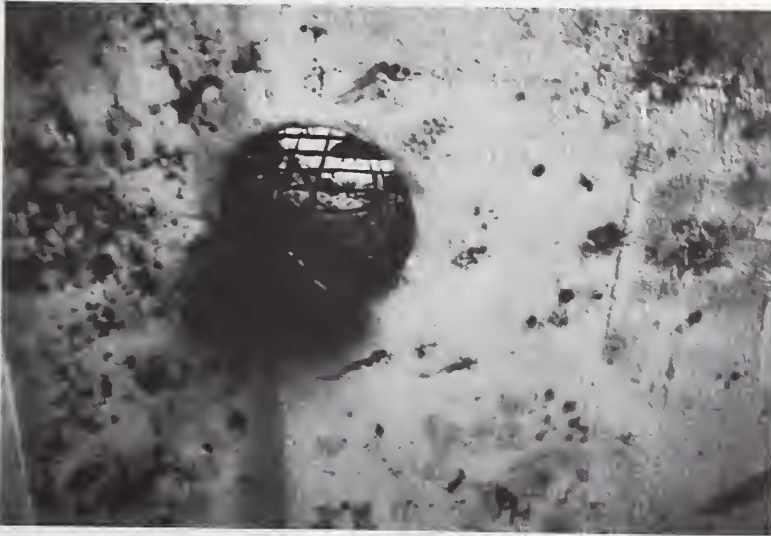
Figure 15. Test 1421X1. Interior view of grating

The battering ram broke through the grating bars and made a hole only about half the required diameter(see fig.15), so the ventilator cover was replaced and the test was restarted using an alternative approach.

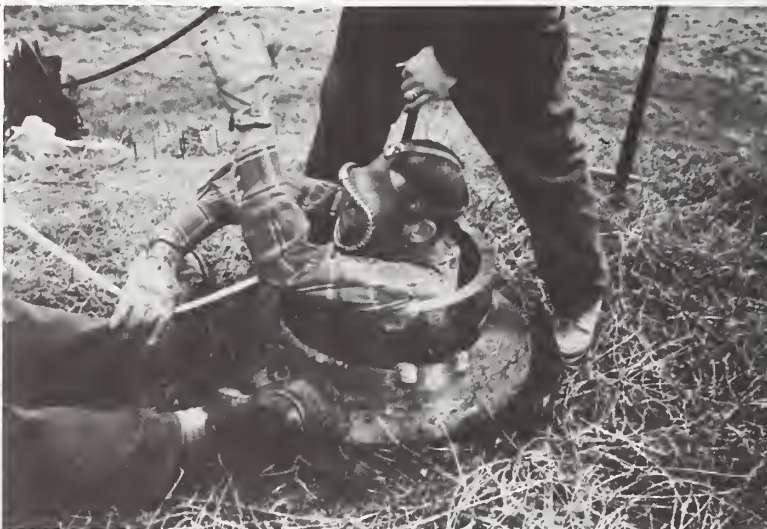
Figure 16. Test 1421X1. Attacker being lowered through ventilator shaft

The breathing apparatus was jury-rigged. A belt was volunteered by one of the attack team and used to try to strap the pressure regulator of the breathing apparatus in such a position that the semirigid air supply line would not kink the hose between the regulator and breathing mask. When this had been done, the intruder was lowered to the interior floor of the magazine using belaying techniques as shown in figure 16. The bottom was reached after 8.70 minutes of working time and 11 minutes elapsed time.

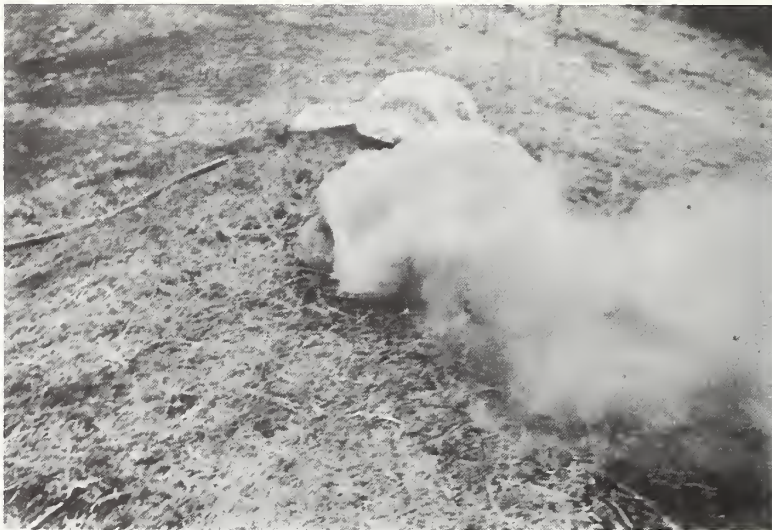
Figure 19. Test 1421X1. Smoke from ventilator after burning grid

After completion of test 1421X1, a grid work of plastic pipes was placed across the interior of the ventilator shaft and connected to a smoke generator. This was to simulate a proposed chemical forced entry deterrent system. The magazine was again closed and the pipe grids were cut with the burning bar. Smoke poured out of the ventilator, as shown in figure 19, and the interior of the magazine was filled with dense smoke. When the doors of the magazine were opened, it was several minutes before there was sufficient visibility to even find the fans which had been placed inside to facilitate forced ventilation and smoke removal. After they had finally been located and turned on, it took nearly half an hour to clear the magazine of smoke. It is believed that unless an invader had been trained to perform his mission in total darkness he could not have functioned in the environment of a closed magazine filled with such dense smoke even using breathing apparatus and portable lights.

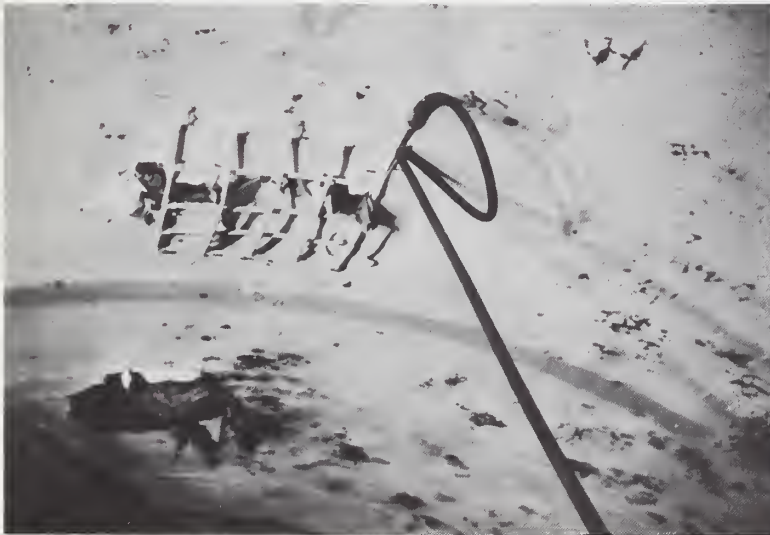
Figure 30. Test 1421W3. Interior grid work showing slight bowing

The following day, the testing was resumed with a fresh supply of sledgehammer handles. The 7.62 cm (3") deep holes were extended to 12.7 cm (5") in depth and were spalled out in 3.95 minutes. On several occasions, punches came through the concrete in positions which threatened to penetrate the pipe grid work attached to the interior of the arch but in each instance the grid was merely bowed or deflected as shown in figure 30.

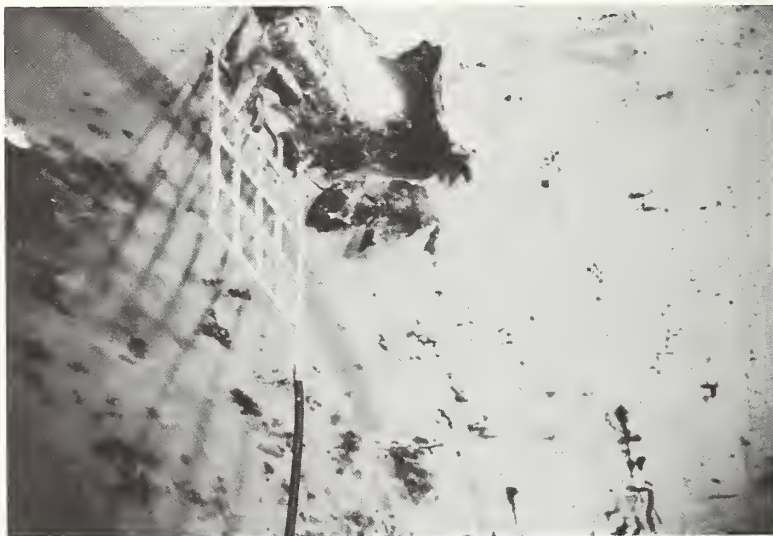
Figure 31. Test 1421W3. Unruptured pipe grid hanging loose from one side

Again the battering ram was dropped, and, on the tenth drop, after a working time of 1.17 minutes, about half of the concrete broke through. Then, 0.42 minute work with the sledgehammer cleared an opening 20.3 cm (8") wide and 54.6 cm (21-1/2") long. In the process, the pipe grid did not rupture but was torn loose from its hangars on one side and hung vertically as shown in figure 31. A final 0.57 minute of work with bolt cutters cleared the remaining reinforcing wires, completing the opening in a total working time of 33.15 minutes.
